Oregon and Washington Drinking Water Providers Partnership

Schooner Creek Sediment Reduction Project

Salmon Drift Creek Watershed Council &
City of Lincoln City

Report Prepared by:

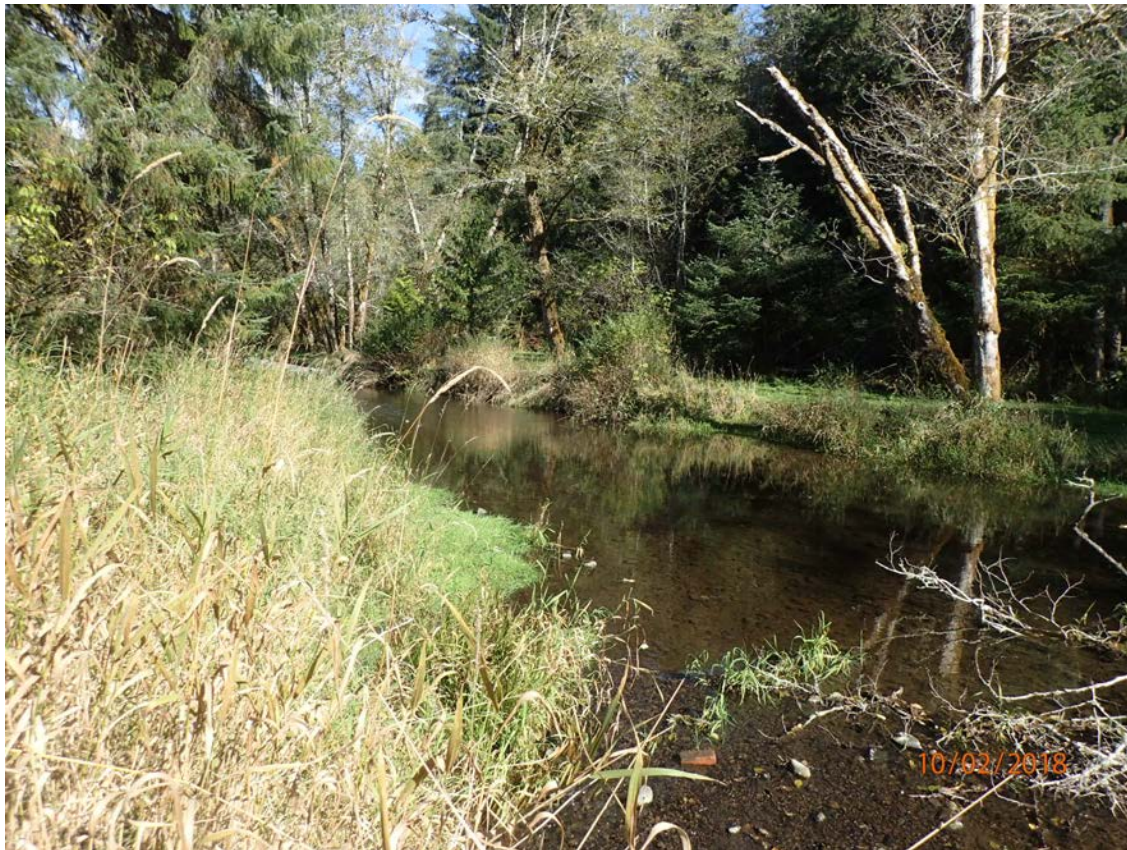
Photo 1. Private residential property at River Mile 3.45 managed as wildlife habitat with a vegetated floodplain.

Photo 1. River Mile 3.45 is an example of a flat, vegetated floodplain that is a good fine sediment catcher. There are seven landowners in this important stream reach. Several landowners are managing for wildlife habitat. The SDCWC can explore ways to help the landowners keep their floodplains well vegetated.

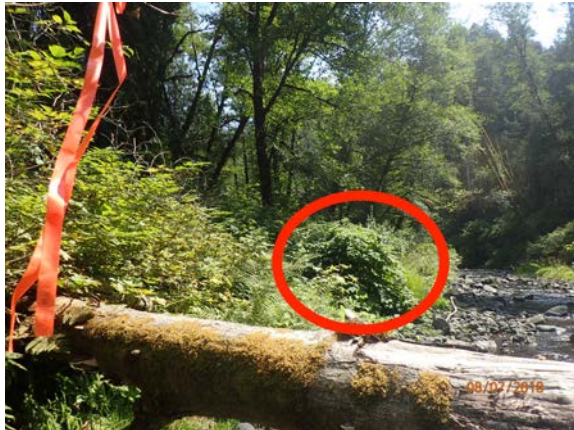
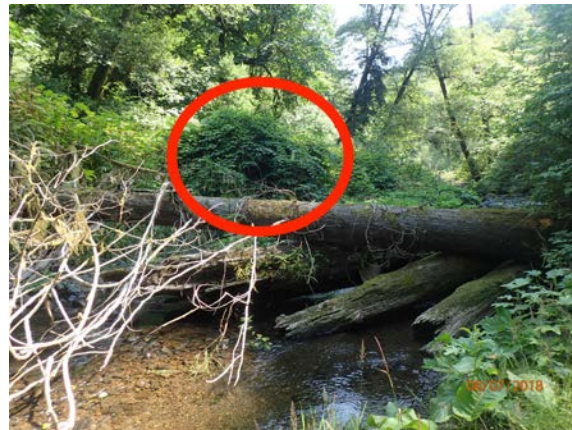
Knotweed photos taken above River Mile 6.5.

Schooner Creek, from the upstream extent of residential property at River Mile 5.5 to the North/South Forks junction at River Mile 7.7 is mixed private industrial forestland and US Forest Service ownership. The floodplain is typically narrow and well vegetated; stream banks are stable. Two mature knotweed plants were found that could spread this invasive plant down stream reducing vegetation floodplain function and wildlife habitat. We recommend Lincoln Soil and Water Conservation District add these two sites to their invasive plant control efforts.

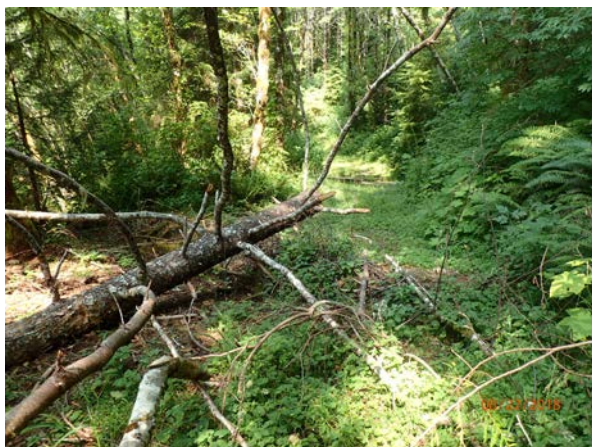
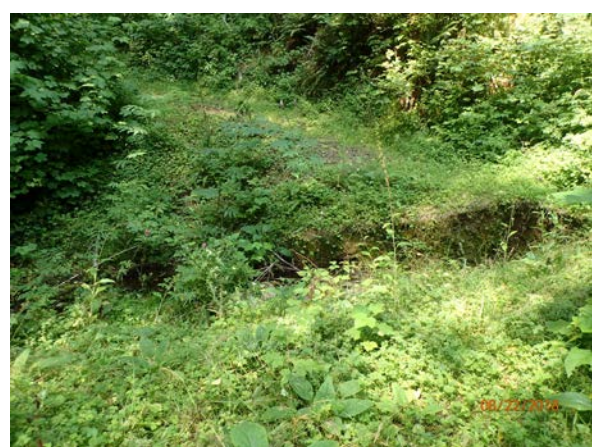
Photos taken along South Fork Schooner Creek Road Decommissioning.

The 1.5 mile long US Forest Service road running parallel to South Fork Schooner Creek was decommissioned. Access to the fish ladder was retained. The decommissioned road surface is not a South Fork Schooner Creek sediment source. Culverts were removed to prevent plugging and road fill failure. We did find continuing erosion at culvert removal locations and recommend follow-up erosion control. Straw and shrub planting erosion control on excavated slopes would be helpful. Five wetted stream channels through the road footprint would benefit from willow planting and rock dissipaters where tributary streams are head cutting.

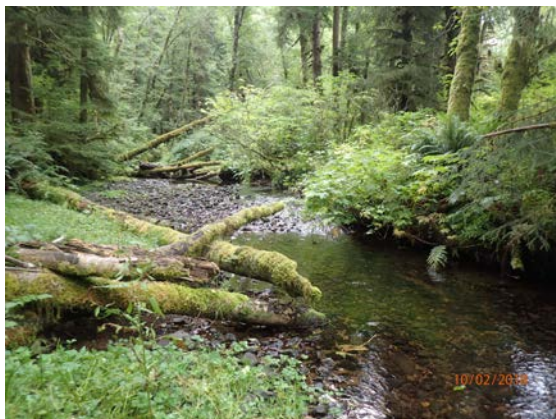
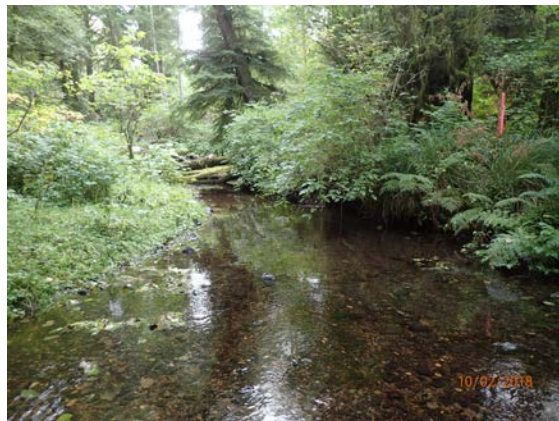
North Fork Schooner with flat stream gradient and well-vegetated floodplains.

North Fork Schooner Creek (Woods and Stone, 2007) flattens out to an average stream gradient of 1.0%. Two aquatic habitat restoration projects have added large wood to this area of North Fork Schooner with good success. The large wood complexes are intact, trapping stream sediments, and providing good winter rearing habitat conditions for juvenile coho salmon. Braided stream channels are common. North Fork Schooner does get up on its floodplain during high stream flows, slowing velocity and dropping fine sediments. There are no erosion control measures needed on the floodplains of North Fork Schooner Creek.
